**METAL MIGRATION FAILURES IN A HYBRID DEVICE:
INTERACTION OF PACKAGE MATERIALS, PROCESS
RESIDUALS, AND AMBIENT GASES**

ISHM 1992 Proceedings, San Francisco, CA

This paper presents a case history of a failure analysis performed on a hybrid package. The package failed during thermal cycle with bias. Electrical testing revealed resistive shorts between Vcc and ground bond pads on integrated circuits within the package. A dendritic growth containing gold and copper extended from Vcc to ground across the surface of the passivation. Crystalline-like corrosion products were observed on the bond pads. The failure mechanism is shown to be an electrochemical corrosion reaction within the hybrid.

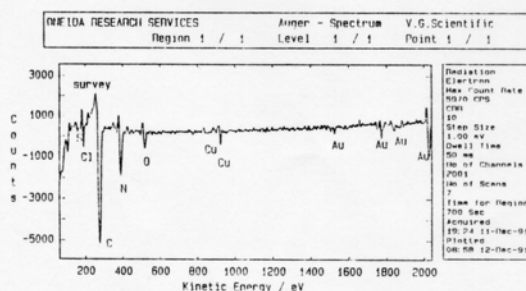
1. Exposure of raw substrate to chlorinated cleaning solvents does not elevate the chlorine levels on the surface of the thick film gold.
2. Assembled hybrids exhibited high levels of chlorine and nitrogen before and after lid seal. The chlorine and nitrogen levels on the surface of the thick film gold increase as a result of the solvent cleaning steps and epoxy curing, Figures 4 and 5. It is possible that the organic adhesives absorbed the chlorinated cleaning solvents. Chlorinated species could then have been evolved from the adhesives and reacted with the copper oxide on the thick film gold.

Figure 5: Auger elemental survey of substrate metallization following lid seal

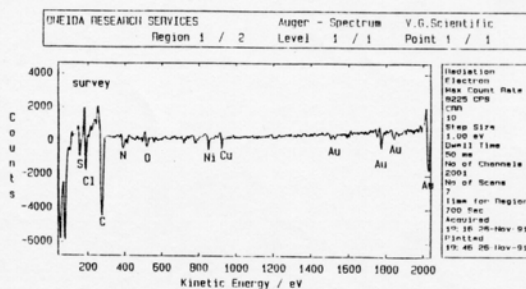
3. Copper migration occurs throughout the package during the lid seal process prior to electrical burn-in. Copper was detected on the package lid (only on internal side), and on other components within the hybrid. The source of copper is the thick film gold metallization. The amount of copper oxide (roughly 100-300 angstroms thick) on the surface of the metallization in the raw substrates is very sensitive to firing conditions (time, temperature, forming gas, etc.), and the amount of copper oxide in the thick film ink⁽¹⁵⁾. Ratios of copper to gold peak heights show a reduction in the amount of copper in the thick film gold ongoing from the raw substrate to the virgin hybrid to the failed hybrid, Table II. This trend suggests that the copper oxide is being consumed by reactions with constituents in the package ambient during the assembly process and electrical burn-in/temperature cycling. The trend correlates with the observed copper migration from the metallization to other areas with the hybrid.

Figure 6: Auger elemental survey of package lid following lid seal
