FAILURE ANALYSIS OF A HYBRID DEVICE EXHIBITING COPPER DENDRITE GROWTH ON THICK FILM RESISTORS

Jeffrey B. Dixon, Mark R. Northrup, Daniel T. Rooney

Oneida Research Services, Inc.
1 Halsey Road
Whitesboro, New York 13492, USA

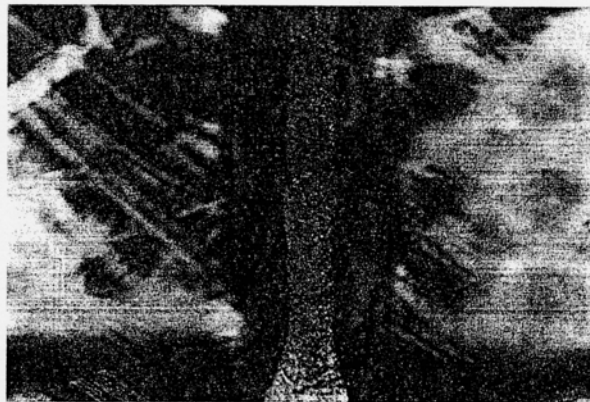
INTERNAL INSPECTION - The failed and good hybrids were delidded and underwent light microscopy and SEM inspection. Light photographs of the laser trim in the failed devices show the copper-colored material across the laser trim (Figure 1). The laser trims exhibited a narrowing of the kerf in the region of the copper-colored material. Comparative photographs from a "good" device in Figure 2 show no narrowing and a trim region devoid of the copper-colored material.

Figure 1. Light micrograph of a laser trim on a failed hybrid.

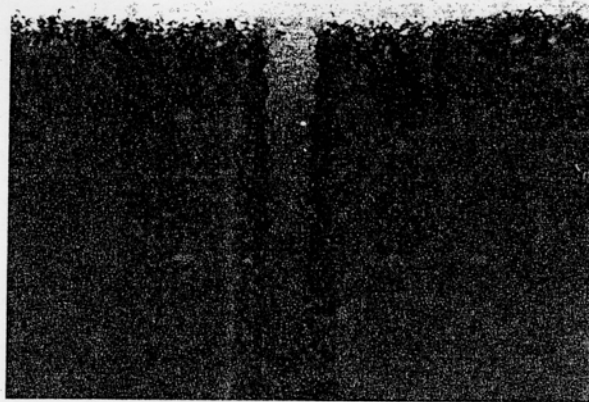
Figure 2. Light micrograph of a laser trim on a "good" hybrid.

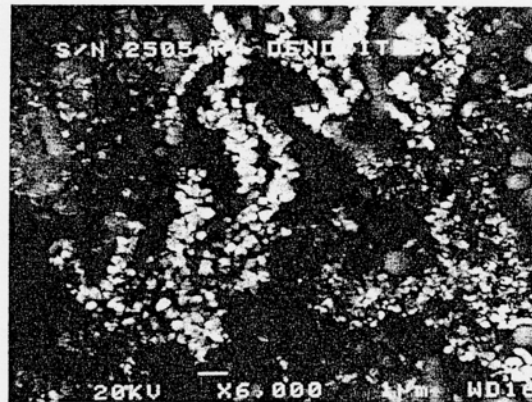
SEM inspection of the morphology of the copper-colored material indicated that it was dendritic growth (Figure 3). The dendrites show a granular structure rather than the more typical dendritic fern structure.

Figure 3. SEM photograph of dendrites.

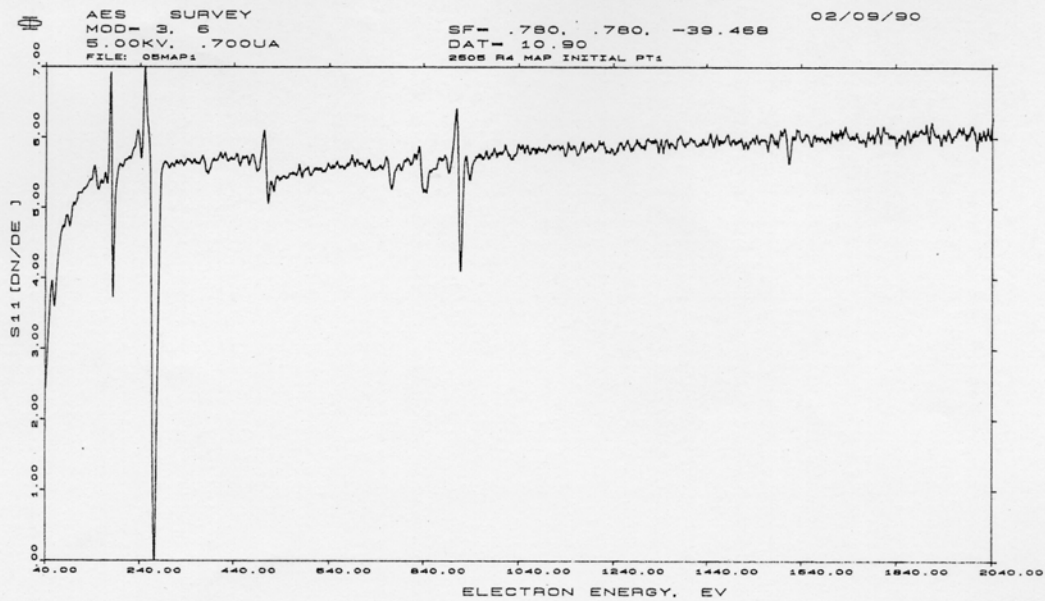
Laser Trims (Kerfs) Failed Hybrid - A representative elemental survey of the copper-colored material in the laser trim is shown in Figure

4. High levels of chlorine and copper were detected in this region of the kerf, demonstrating that the copper-colored material is associated with the deposition of copper in the kerf.

Figure 4. Auger elemental survey of material in failed hybrid laser trim.

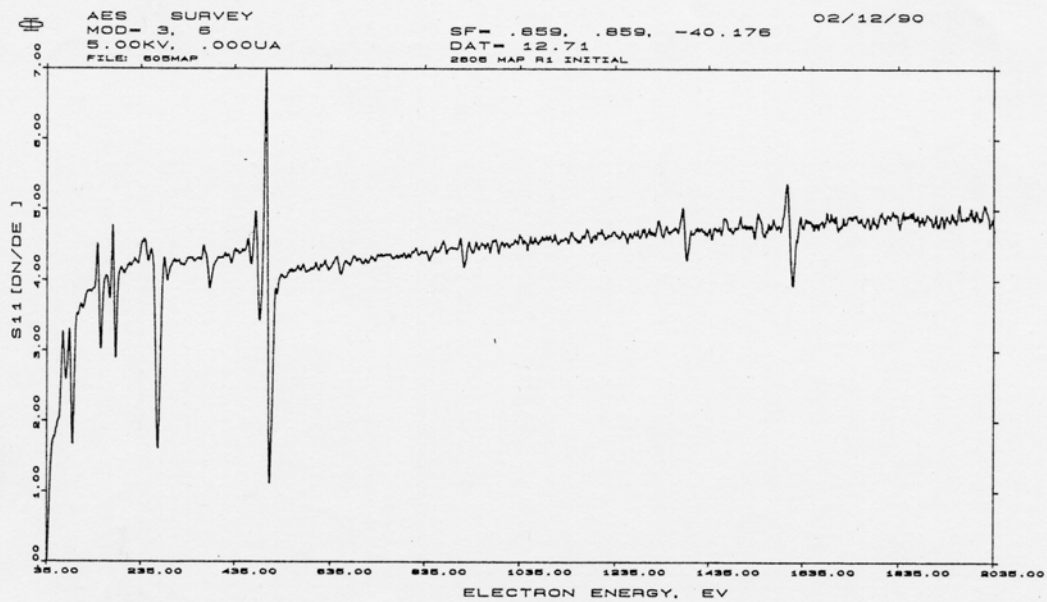
Laser Trims (Kerfs) Good Hybrid - Elemental surveys were collected in a region of a kerf analogous to that analyzed in the failed hybrid. A representative survey showed levels of chlorine typically associated with handling contamination (Figure 5). Copper is detected in this region, but at a level just above the noise level, indicating that copper migration had occurred in the good device, but not to the same extent as in the failed hybrid.

Figure 5. Auger elemental survey of material in "good" hybrid laser trim.

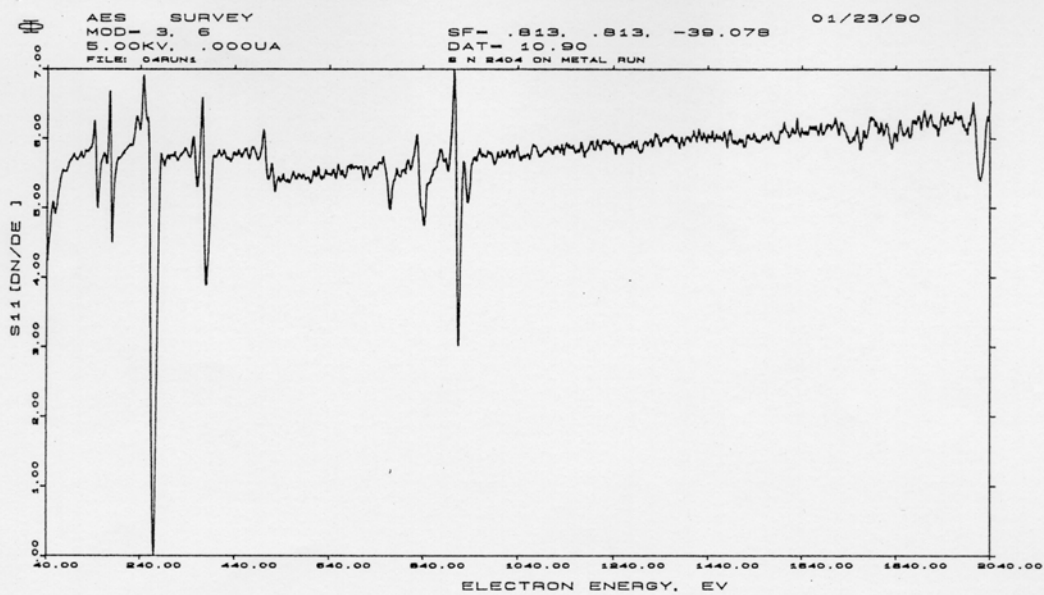
Thick Film Gold Conductors Failed Hybrid (Assembled) - A survey of the conductor showed that significant levels of copper are detected on its surface (Figure 6). The thickness of the copper is approximately 400 Å. The amount of oxygen was much lower than that observed in the depth profile of the conductor material on the failed substrate lot prior to assembly and burn-in. The copper-to-gold ratio in the depth profile of the assembled hybrid is lower than in the hybrid prior to assembly (Figure 7).

Figure 6. Auger elemental survey of a thick film conductor on a failed hybrid substrate (assembled).

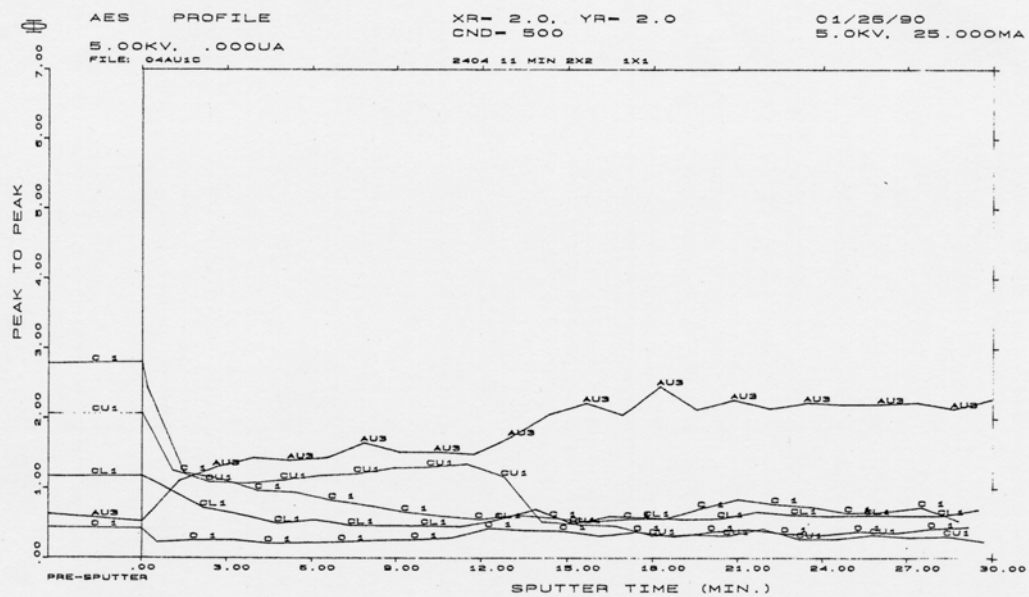
Figure 7. Auger depth profile of a thick film conductor on a failed hybrid substrate (assembled).

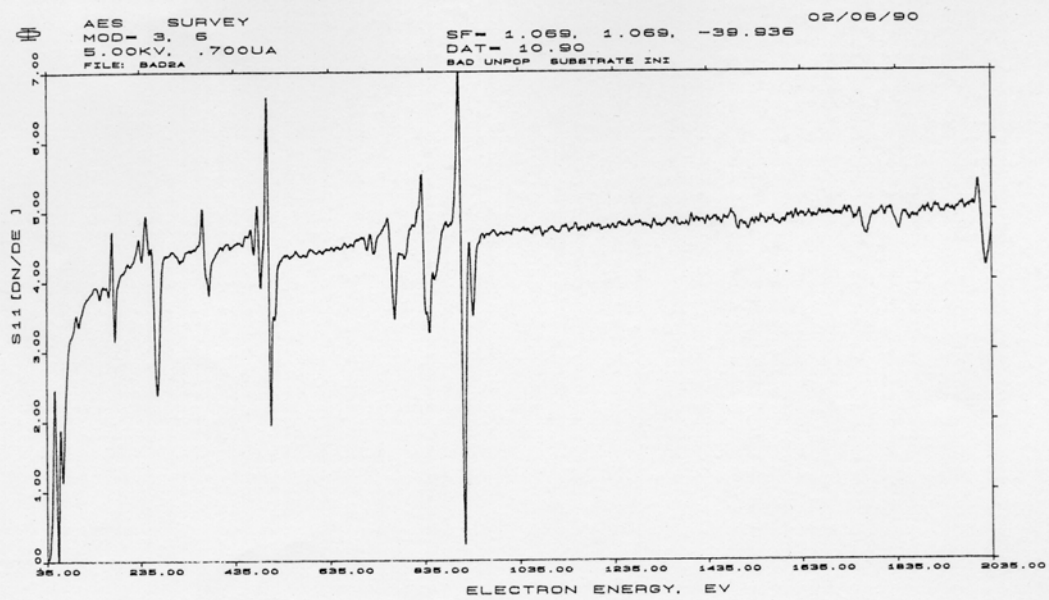
Failed Substrate Lot (Unassembled) - A survey of the conductor showed significant levels of copper and oxygen on the surface of the gold (Figure 8). The depth profile shows that the copper thickness is very similar to that on the failed hybrid conductor (Figure 9). The copper is, however, associated with oxygen on the unassembled substrate and appears to be in greater abundance relative to the assembled hybrid. The presence of CuO on the surface of the conductor prior to burn-in and the absence of CuO following burn-in is consistent with the hypothesis that CuO was removed by an electrochemical corrosion reaction.

Figure 8. Auger elemental survey of a thick film conductor from the failed substrate lot (unassembled).

To prevent similar failures with hybrid devices we recommend that: (1) Auger depth profiles be performed on representative samples of raw substrates prior to assembly to screen for bad ink lots; (2) the halogens in cleaning solvents be properly removed so that they do not contribute to the formation of an electrochemical cell. Vacuum bake procedures should be developed for effective removal of residual process materials, and evaluated by RGA testing.

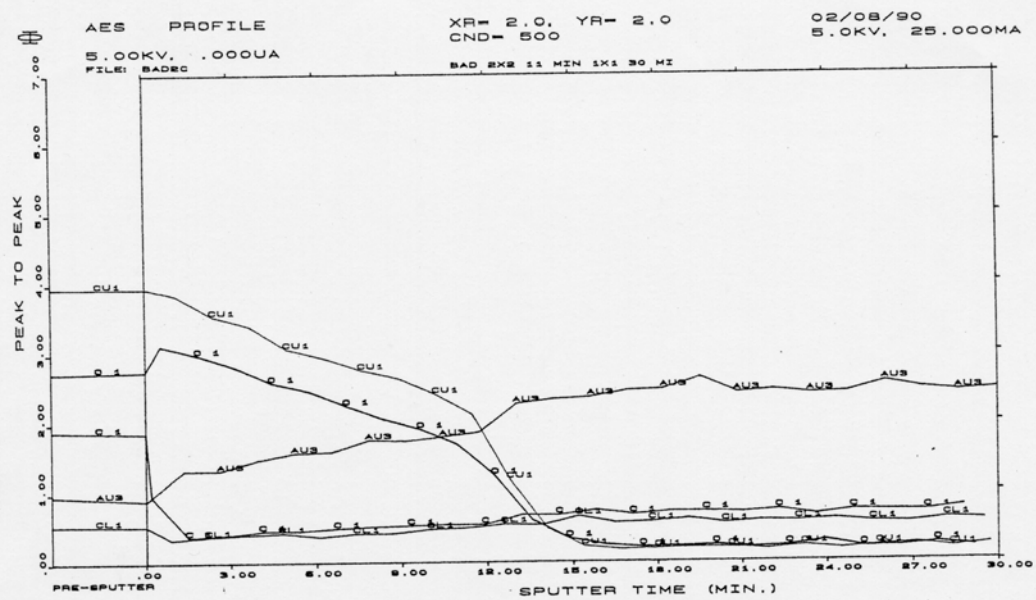
Figure 9. Auger depth profile of a thick film conductor from the failed substrate lot (unassembled).

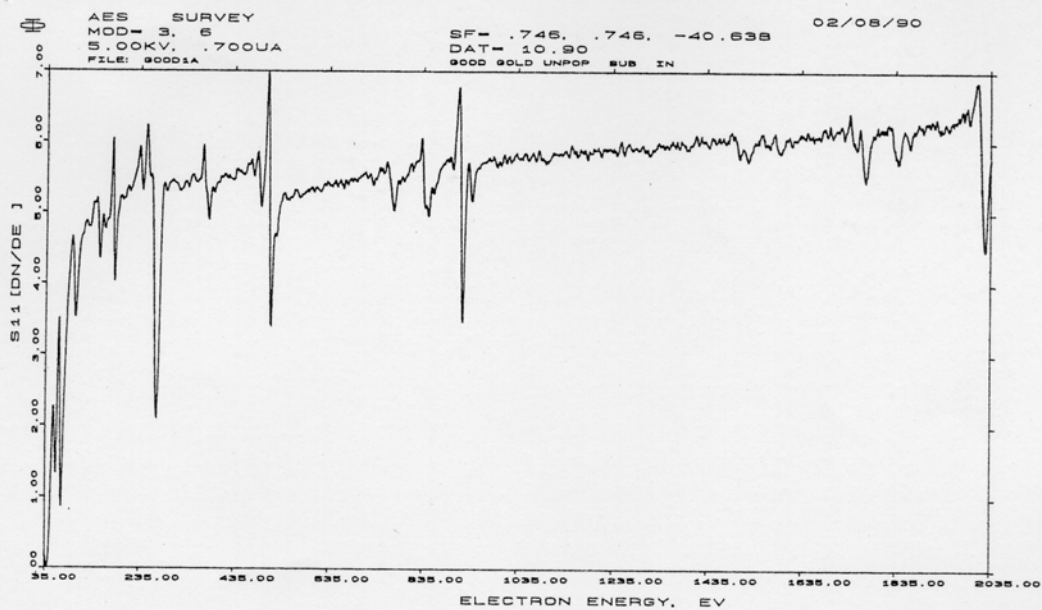
Good Substrate Lot (Unassembled) - A survey of the conductor shows copper and oxygen on the surface (Figure 10). The depth profile revealed a much thinner copper layer relative to the failed substrate lot (Figure 11). (This profile was collected using the same ion gun parameters used

Figure 10. Auger elemental survey of a thick film conductor from the "good" substrate lot (unassembled).

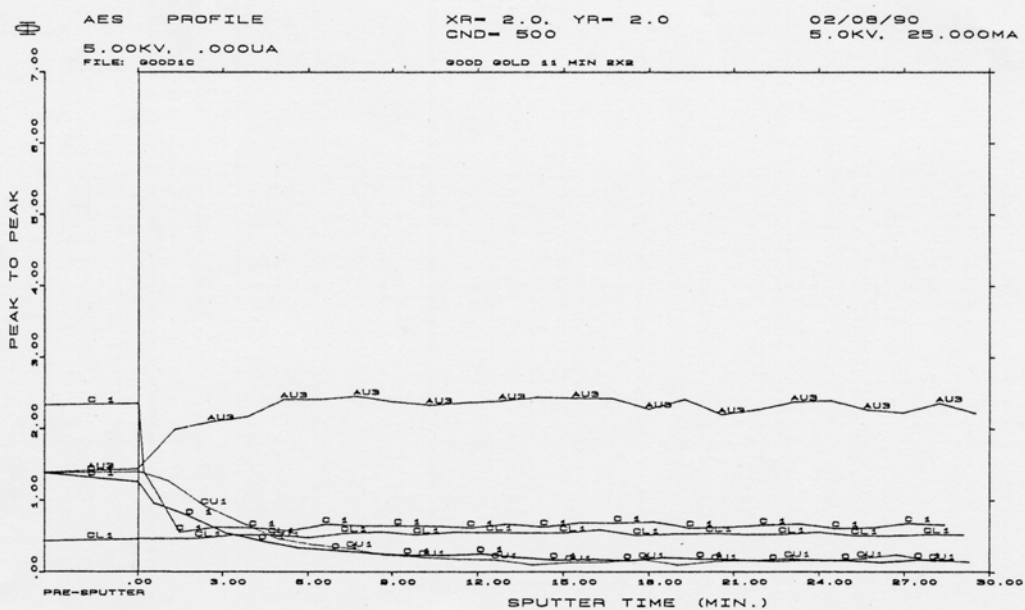
on the failed substrates.) The oxygen is assumed to be associated with the copper since both follow similar elemental trends in the profile.

Figure 11. Auger depth profile of a thick film conductor from the "good" substrate lot (unassembled).

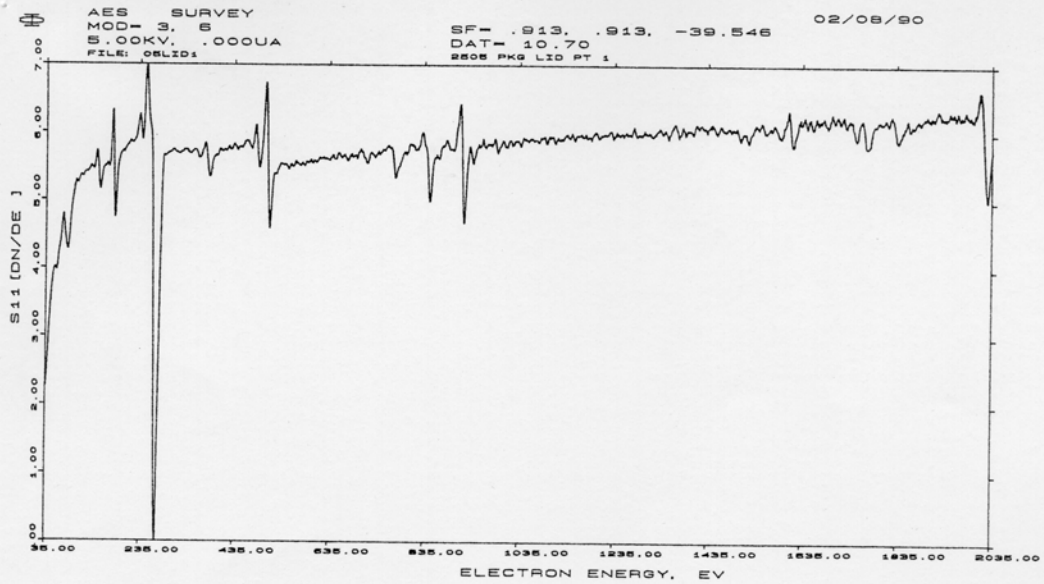
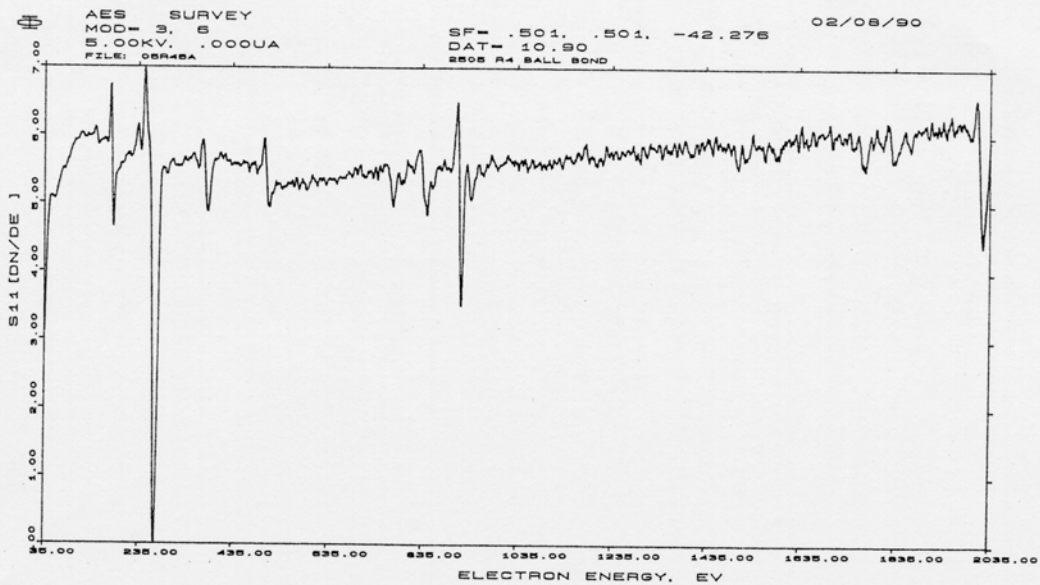
Other Components (Failed Hybrid) - Elemental surveys were collected on the package lid and on a ball bond to determine the extent of copper migration (Figures 12 and 13). Both surveys show copper and chlorine contamination, illustrating the large extent of the copper migration within the failed hybrid.

Figure 12. Auger elemental survey of a package lid from a failed hybrid.

Figure 13. Auger elemental survey of a ball bond on a failed hybrid.

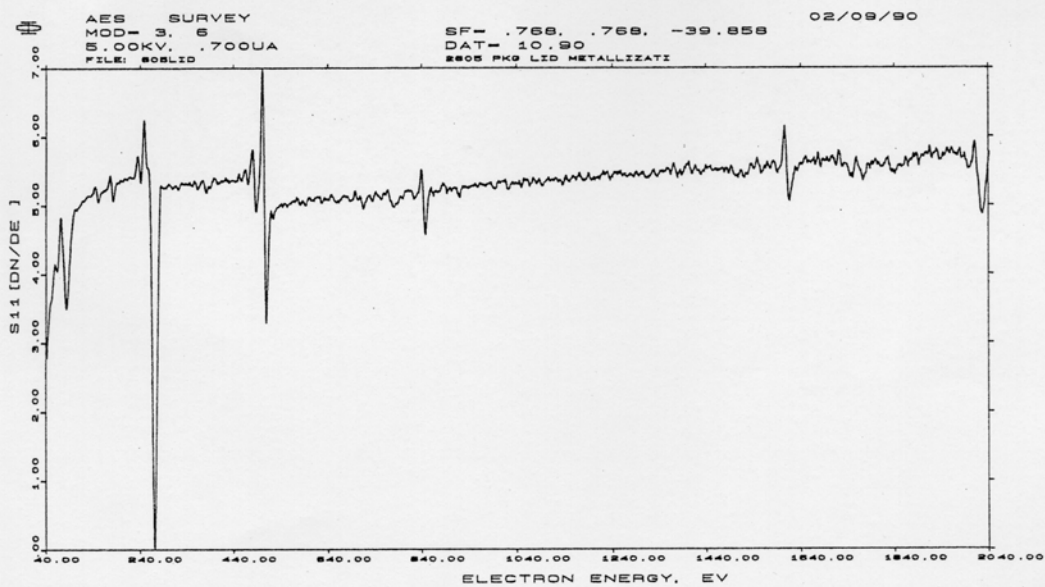
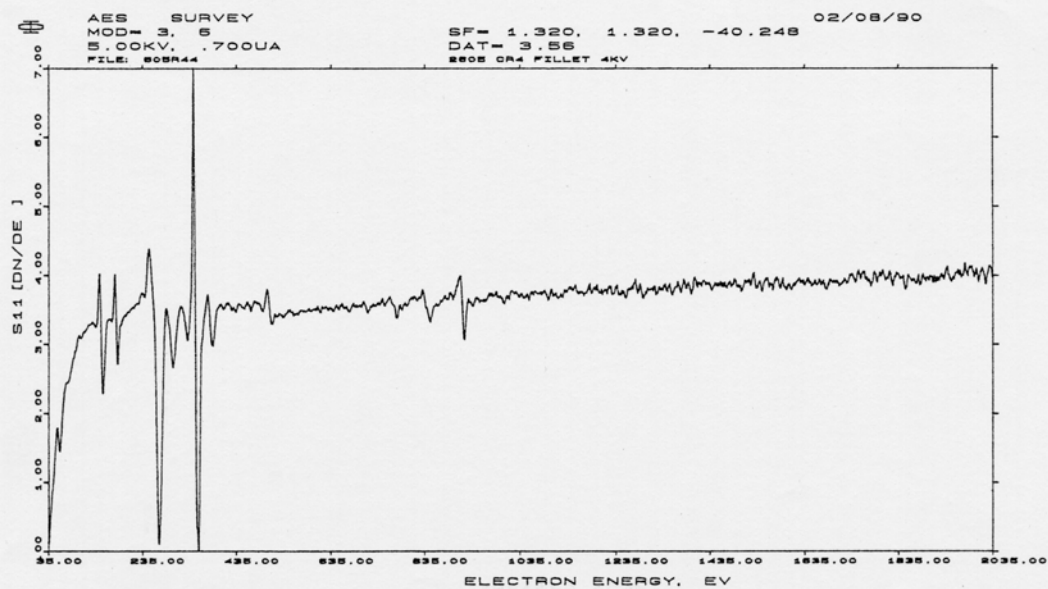
Other Components (Good Hybrid) - Elemental surveys were collected on the package lid and on the die attach fillet to determine the extent of copper migration (Figures 14 and 15). Copper was not detected on the surface of the package lid. Copper was detected in the die attach fillet, but elevated levels of chlorine were not observed. This indicated a much lower migration of copper within the good hybrid.

Figure 14. Auger elemental survey of a package lid from a "good" hybrid.

Figure 15. Auger elemental survey of a die attach fillet on a "good" hybrid.
