**METAL MIGRATION FAILURES IN A HYBRID DEVICE:
INTERACTION OF PACKAGE MATERIALS, PROCESS
RESIDUALS, AND AMBIENT GASES**

J.B. Dixon, D.T. Rooney and N.T. Castello

**Oneida Research Services, Inc.
One Halsey Road
Whitesboro, NY 13492**

ISHM 1992 Proceedings, San Francisco, CA

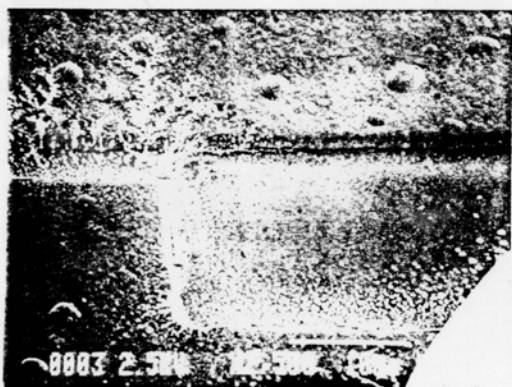
Internal inspection was performed using light microscopy and SEM. Two forms of contamination were observed on the surface of two die in the hybrid. The first was a dendritic growth extending from the bond pads across the passivation, Figure 1. The extent of the dendritic growth was particularly heavy between the Vcc and ground bond pads. Some of the failed devices had degraded to the point that the Vcc ball bond was consumed in the corrosion reaction. The degradation appeared to be a textbook case of the anodic dissolution of the Vcc gold ball bond. The second form of contamination was a crystalline-like growth found on several bond pads. The crystalline-like growth had an opaque appearance.

The significant results of this failure analysis are summarized as follows: (1) The resistive electrical shorts between Vcc and ground were primarily due to a dendritic growth resulting from the anodic dissolution of the Vcc bond wire; (2) Electrical bias and temperature cycling from -55 to 150°C provided the driving force behind three different electrochemical corrosion reactions, and also allowed for the condensation of ammonia and moisture on surfaces within the hybrid; (3) A reaction between constituents in the package atmosphere with copper oxide on surface of the thick film gold substrate metallization resulted in copper migration throughout the package cavity; (4) Chlorinated cleaning solvents and epoxy off-gassing products must be properly removed to prevent future occurrences of similar failures.

Figure 1: SEM photograph of dendrites, 2500X

To prevent the occurrence of similar failures we recommend that: (1) IC designs with Vcc and ground located at adjacent bond pads should be avoided; (2) Halogenated cleaning solvents must be properly removed so that they do not contribute chlorine to the formation of an electrochemical cell; (3) Vacuum bake procedures should be developed for effective removal of epoxy outgassing species and other process residuals; (4) RGA screening can be conducted to evaluate the effectiveness of the vacuum bake procedures.

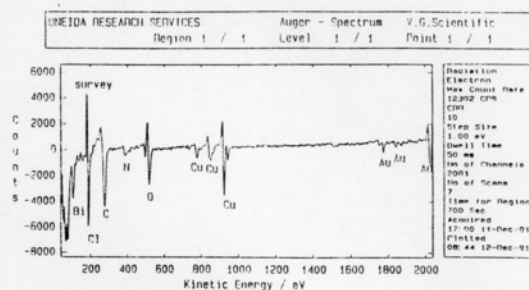
1. Exposure of raw substrate to chlorinated cleaning solvents does not elevate the chlorine levels on the surface of the thick film gold.
2. Assembled hybrids exhibited high levels of chlorine and nitrogen before and after lid seal. The chlorine and nitrogen levels on the surface of the thick film gold increase as a result of the solvent cleaning steps and epoxy curing, Figures 4 and 5. It is possible that the organic adhesives absorbed the chlorinated cleaning solvents. Chlorinated species could then have been evolved from the adhesives and reacted with the copper oxide on the thick film gold.

Figure 4: Auger elemental survey of substrate metallization prior to lid seal

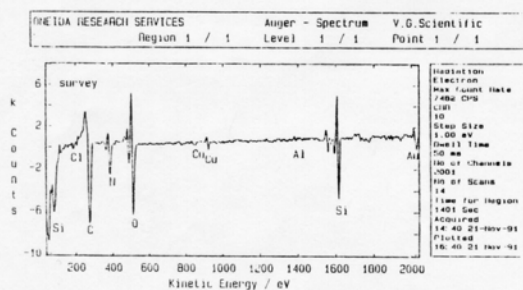
Auger analysis was performed to determine the surface constituents associated with the dendrites. Auger elemental surveys yield information on the top 5 to 40 angstroms of material. The surveys of the dendrites exhibited gold, copper, carbon, oxygen,

nitrogen, chlorine, and silicon, Figure 2. The passivation is a silicon nitride and may contribute the silicon, nitrogen, and oxygen in the surveys of the dendrites. The source of gold for the dendritic growth is the ball bond at the Vcc bond pad. The wirebond material is pure gold, so it is not the source of the copper associated with the dendrites. The only source of copper detected by extensive AES and EDX analysis of raw hybrid construction materials was the copper oxide used in the thick film gold paste.

Figure 2: Auger elemental survey of dendrites

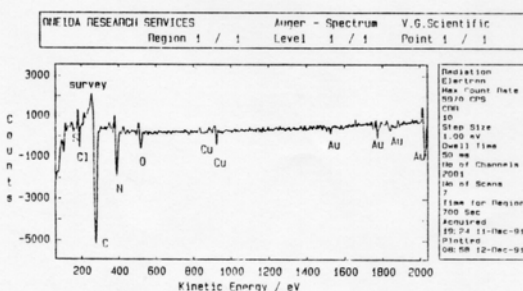
Figure 5: Auger elemental survey of substrate metallization following lid seal

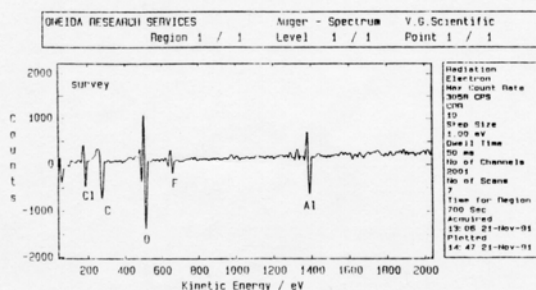
Auger surveys of the crystals showed aluminum, chlorine, oxygen, fluorine, and carbon, Figure 3. This indicates that the crystals are associated with corrosion of the aluminum bond pads.

Figure 3: Auger elemental survey of crystalline-like growth

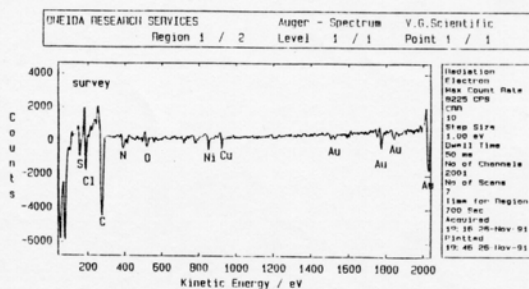
Auger surveys were collected on bond wires, thick film substrate metallization, and on the package lid to determine the extent of copper migration throughout the package. Surveys acquired on the gold-plated package lid and gold bond wires showed significant levels of copper, chlorine, and nitrogen.

3. Copper migration occurs throughout the package during the lid seal process prior to electrical burn-in. Copper was detected on the package lid (only on internal side), and on other components within the hybrid. The source of copper is the thick film gold metallization. The amount of copper oxide (roughly 100-300 angstroms thick) on the surface of the metallization in the raw substrates is very sensitive to firing conditions (time, temperature, forming gas, etc.), and the amount of copper oxide in the thick film ink⁽¹⁵⁾. Ratios of copper to gold peak heights show a reduction in the amount of copper in the thick film gold ongoing from the raw substrate to the virgin hybrid to the failed hybrid, Table II. This trend suggests that the copper oxide is being consumed by reactions with constituents in the package ambient during the assembly process and electrical burn-in/temperature cycling. The trend correlates with the observed copper migration from the metallization to other areas with the hybrid.

Figure 6: Auger elemental survey of package lid following lid seal
